FIELD SERVICE BULLETIN

FSB Number: FSB-015

Title: Switch Mode Power Supply

System Description: All 1200 series projectors

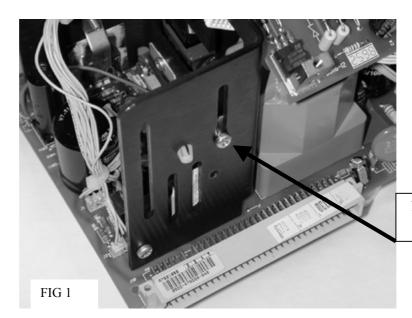
- ♦ NB The body of the 2SC3998 is much larger; and as a consequence, the same hole in the heatsink can no longer be used for securing the bracket supporting the MOSFET. It will need to be mounted higher. The cutout on the heatsink above the original hole can be used for mounting the stainless steel bracket to support the new device (see picture 1)

New fixation for transistor securing bracket

- Shift the mica insulator upwards to guarantee good insulation from the heatsink
- Apply some heatsink compound to improve the thermal contact with the heatsink.
