## PJI EXT-HD (Batch 1) Upgrade Document

1. Remove Edge Enhance problem
2. Heat-sink installation to protect HDMI chip
3. MCU software upgrade, remove IR hang and color (green) problem

EXT-HD VGA and BNC version (include DVI output version)

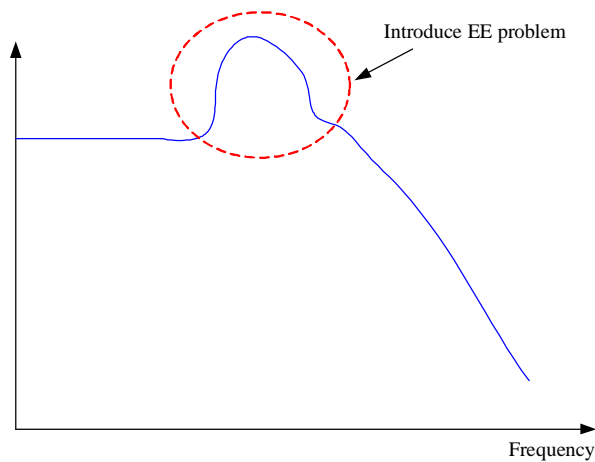
The Video OP on EXT-HD has very high bandwidth and high speed. And there are some diodes used for gamma boost. The diode vendor sent the wrong type of diode to PJI Inc. The Wrong type of diode (have S4 marking) have 15 times larger capacitance than correct diode (marking is S1 or S2 or S3), the capacitance introduce a gain boost at high frequency (about 10MHz~100MHz). So the high frequency component in video signal and anti-aliasing noise from DAC will amply cause ring (edge too sharp), **change to correct diode and add a post filter between DAC and Video OP will solve this problem**

OP Gain vs Frequency with incorrect diode

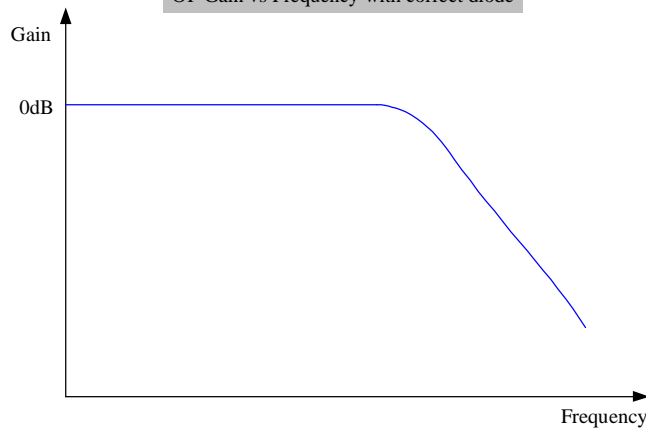
OP Gain vs Frequency with correct diode

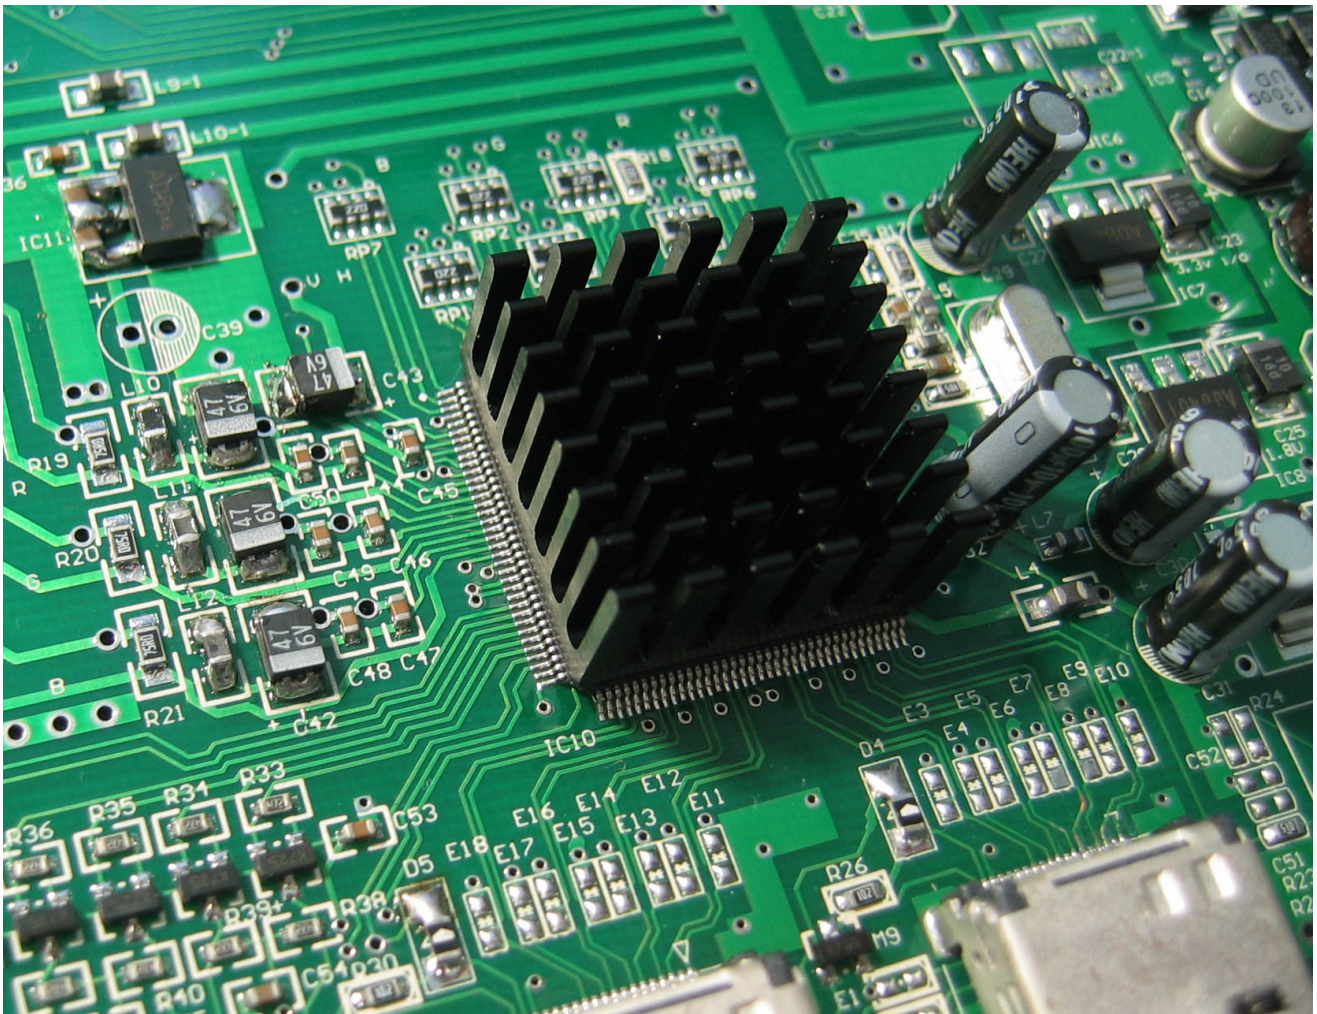
## 2. Add the Heat-sink for HDMI chip:

When running 1080p HD signal the chip may be too heat, add a heat-sink can longer the chip life.

1. remove the paper on the heat sink
2. Attaches the heat sink on the HDMI chip
