FIELD SERVICE BULLETIN

FSB Number: FSB-015

Title: Switch Mode Power Supply

System Description: All 1200 series projectors

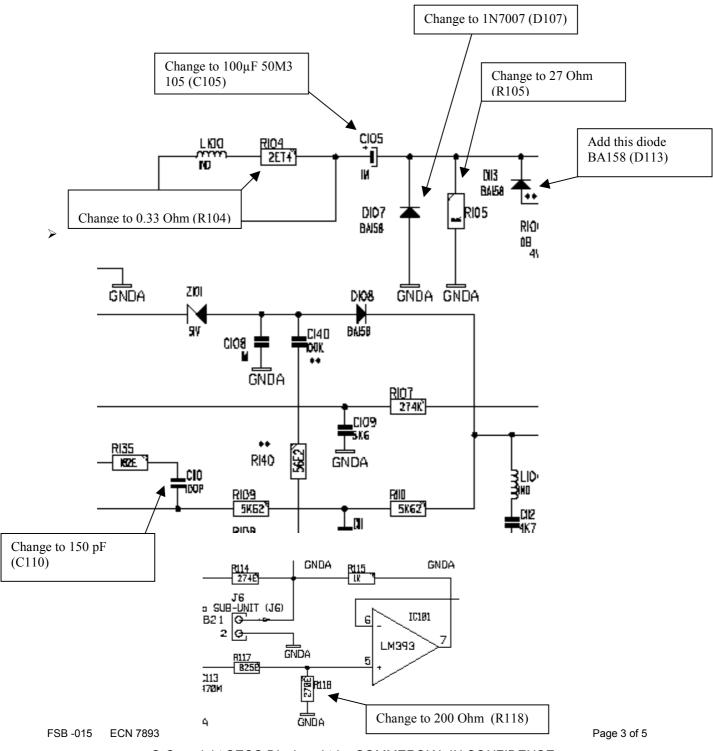
- ♦ NB The body of the 2SC3998 is much larger; and as a consequence, the same hole in the heatsink can no longer be used for securing the bracket supporting the MOSFET. It will need to be mounted higher. The cutout on the heatsink above the original hole can be used for mounting the stainless steel bracket to support the new device (see picture 1)

- \triangleright C105 (1µF) has to be replaced by a 100µF (V1114874).
- ➤ R118 (270E) has to be replaced by a 200E 0W6 (V1026295).
- Mount the new transistor **2SC3998** (B133124) in the same holes as the MOSFET.

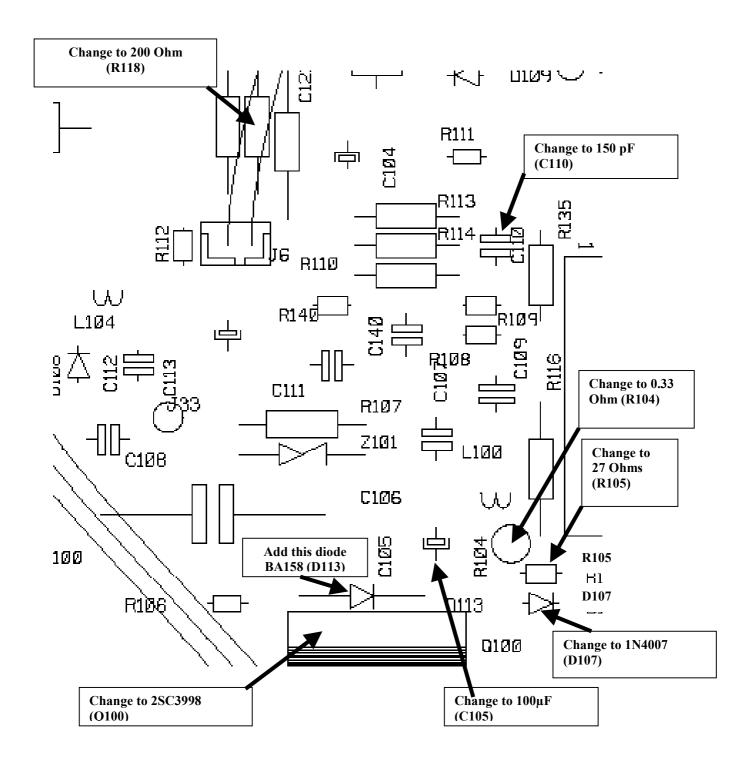
b) If the projector is equipped with a BUP101 transistor which has failed you will need to replace it with a 2SC3998.

Instructions for replacing BUP101 → 2SC3998

All that is required for this modification is to replace C110 (1n2) with a 150pF (V1122842)
